5.0 Falls City, Texas, Disposal Site

5.1 Compliance Summary

The Falls City, Texas, Disposal Site, inspected on January 31, 2007, was in excellent condition. Deep-rooted woody vegetation continues to encroach on the top and side slopes of the disposal cell, requiring control. The turf on the disposal cell top and the remainder of the site appears to have recovered from drought conditions. Groundwater monitoring was performed; historical trends continue. The revised LTSP was submitted to NRC; concurrence is pending. No maintenance needs or cause for a follow-up or contingency inspection were identified.

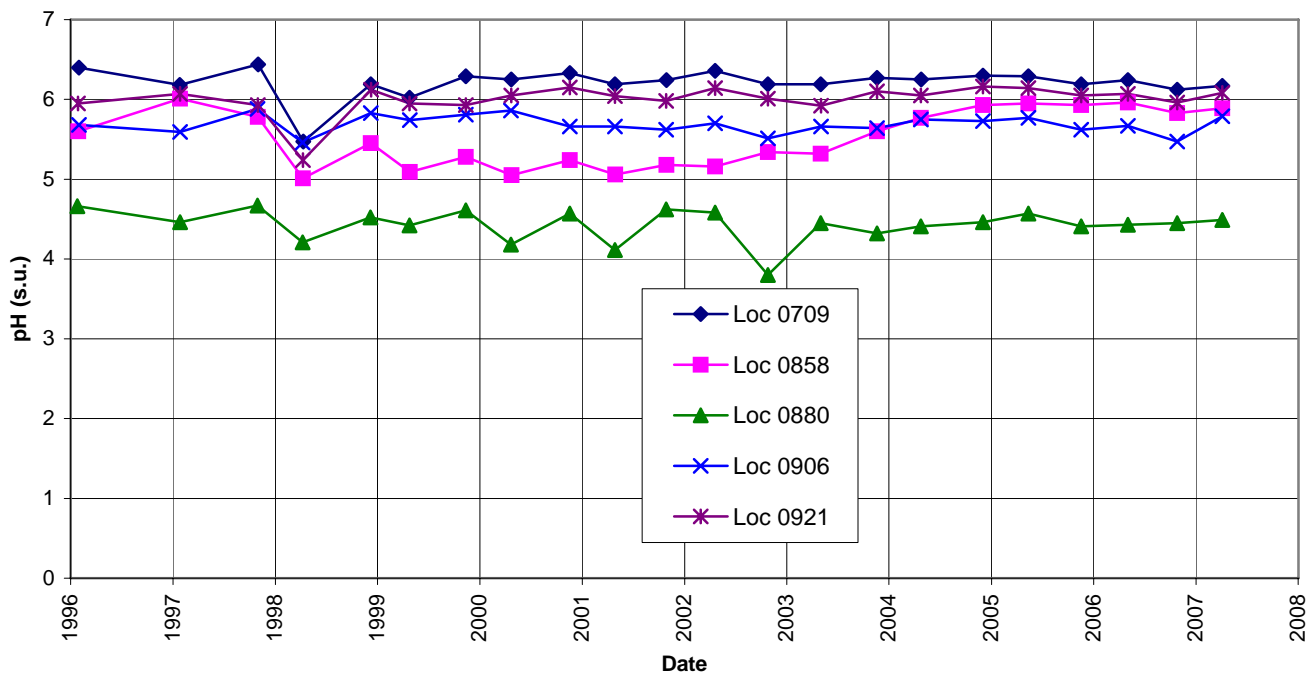
Figure 5-3. pH in Groundwater at Cell Performance Monitoring Locations at the Falls City, Texas, Disposal Site

Groundwater Quality Monitoring Results—At cell performance wells, pH levels have historically shown consistency (within approximately one standard unit (s.u.) of measurement) since late 1998; no significant upward or downward trends are evident. In 2007, the pH levels for the cell performance wells remain stable and within historical limits (Figure 5–3).

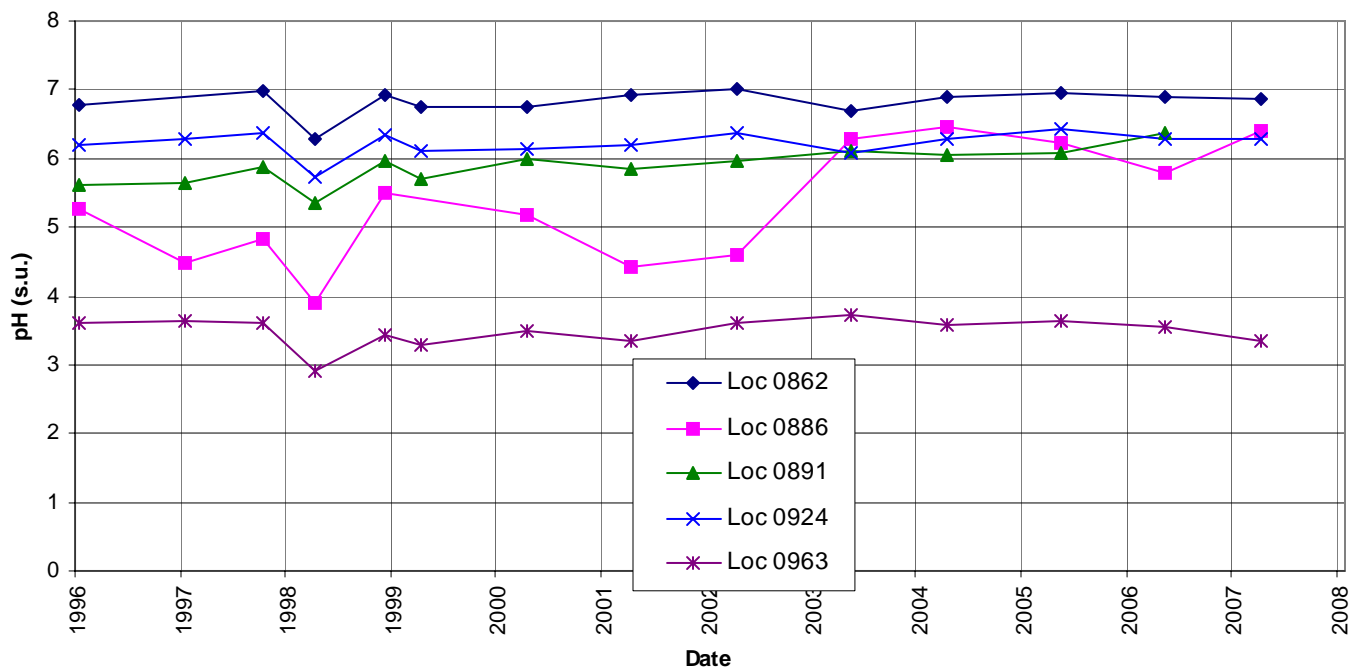
Figure 5-4. pH in Groundwater at Compliance Monitoring Locations at the Falls City, Texas, Disposal Site

The pH levels for this reporting period for the compliance monitoring wells all are within the historical range (Figure 5–4). Wells MW–0886 and MW–0891 show a slight increase, whereas well MW–0963 shows a slight decrease. Both wells MW–0886 and MW–0891 show a slight upward trend (approximately one s.u. since late 1998). Well MW–0891 was not sampled during the April 2007 monitoring event, but was sampled during the October 2007 monitoring event (unavailable, will be included in the 2008 report).

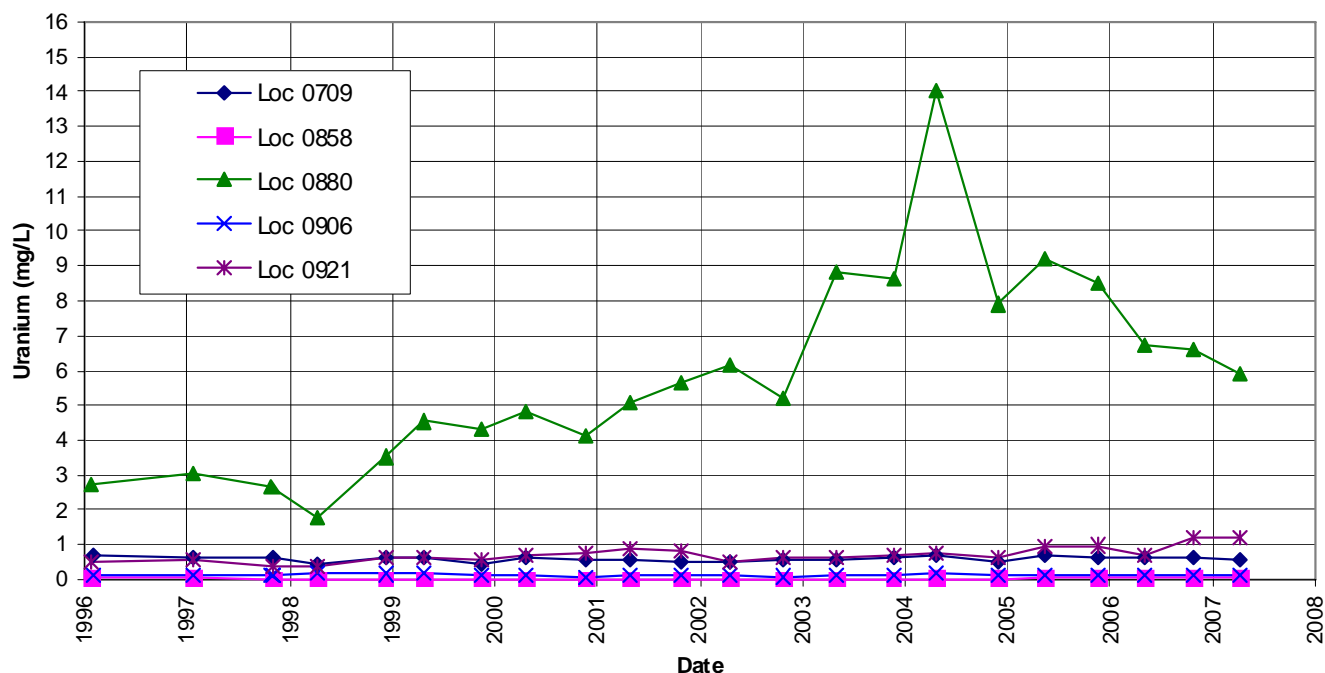
Figure 5-5. Uranium in Groundwater at Cell Performance Monitoring Locations at the Falls City, Texas, Disposal Site

The uranium concentration in the cell performance network well MW–0880 continues a recent downward trend, since 2003–2004 (Figure 5–5). However, historically, the concentration of uranium in monitor well MW–0880 displays an upward trend. The concentration in this well, which has ranged from 2.74 milligrams per liter (mg/L) to 14 mg/L, is substantially greater than the uranium concentrations reported historically in the other site wells (~1.0 mg/L, or less). Although, the sharp increase and maximum concentration reported in April 2004 (14 mg/L) appears anomalous. The explanation for the higher concentration of uranium in this well is not clear, but may be a result of; (1) transient drainage from the disposal cell, (2) residual processing site-related contamination, or (3) the natural redistribution of uranium mineralization. The cause is ambiguous because tailings pore water is very similar chemically to the processing site-related contamination, groundwater at other monitor wells nearby do not show similarly elevated concentrations of uranium, and pH and water levels continue a slight downward trend in well MW–0880.

The uranium concentrations in the remaining cell performance network wells are as follows: Monitor well MW-0921 continues to display a slight upward trend, reaching a maximum of 1.2 mg/L during the last two reported sampling periods. Concentrations at wells MW-0709, MW-0858, and MW-0906 remain less than 1 mg/L and consistent with historical trends (Figure 5-5).

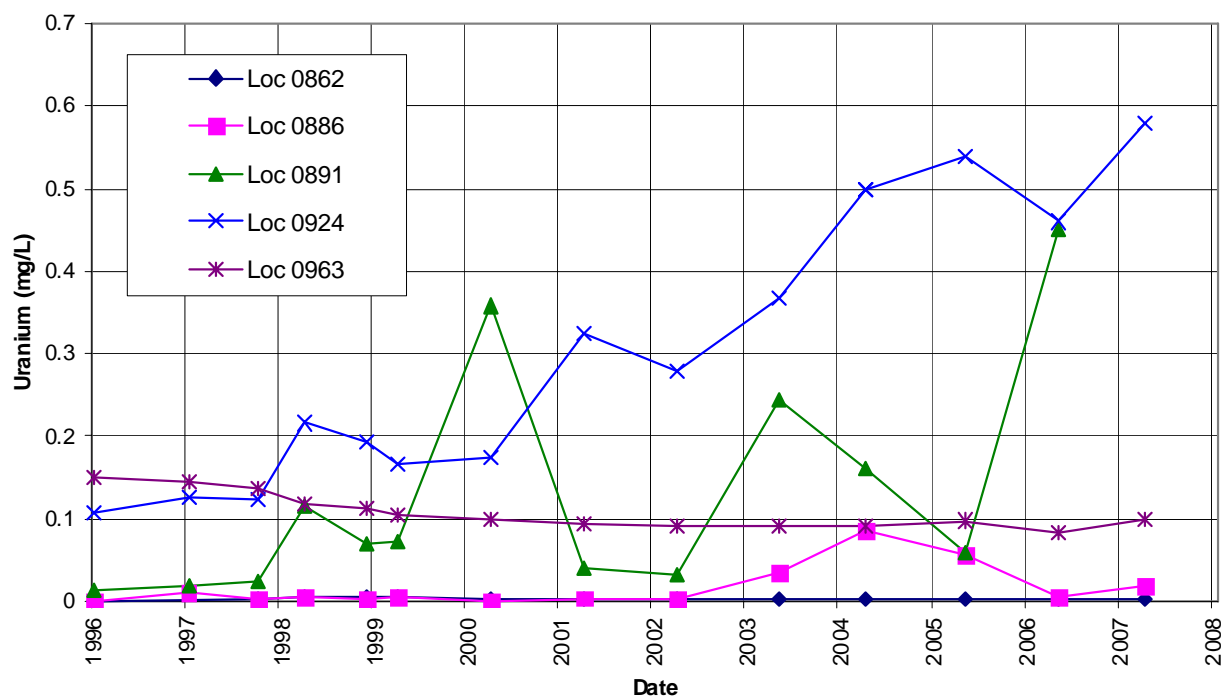
Figure 5–6. Uranium in Groundwater at Compliance Monitoring Locations at the Falls City, Texas, Disposal Site

The uranium concentration in groundwater in compliance monitoring network well MW-0924 continues to display an upward trend (Figure 5-6). In April 2007, well MW-0924 reported the highest concentration (0.58 mg/L) historically for any of the compliance monitoring network wells. Monitor well MW-0891 also displays an upward trend; however, no sample was collected from this well in 2007. Uranium concentrations reported in the remaining three compliance monitoring network wells in 2007 were all within the historical range (<0.15 mg/L), with no significant trends evident.

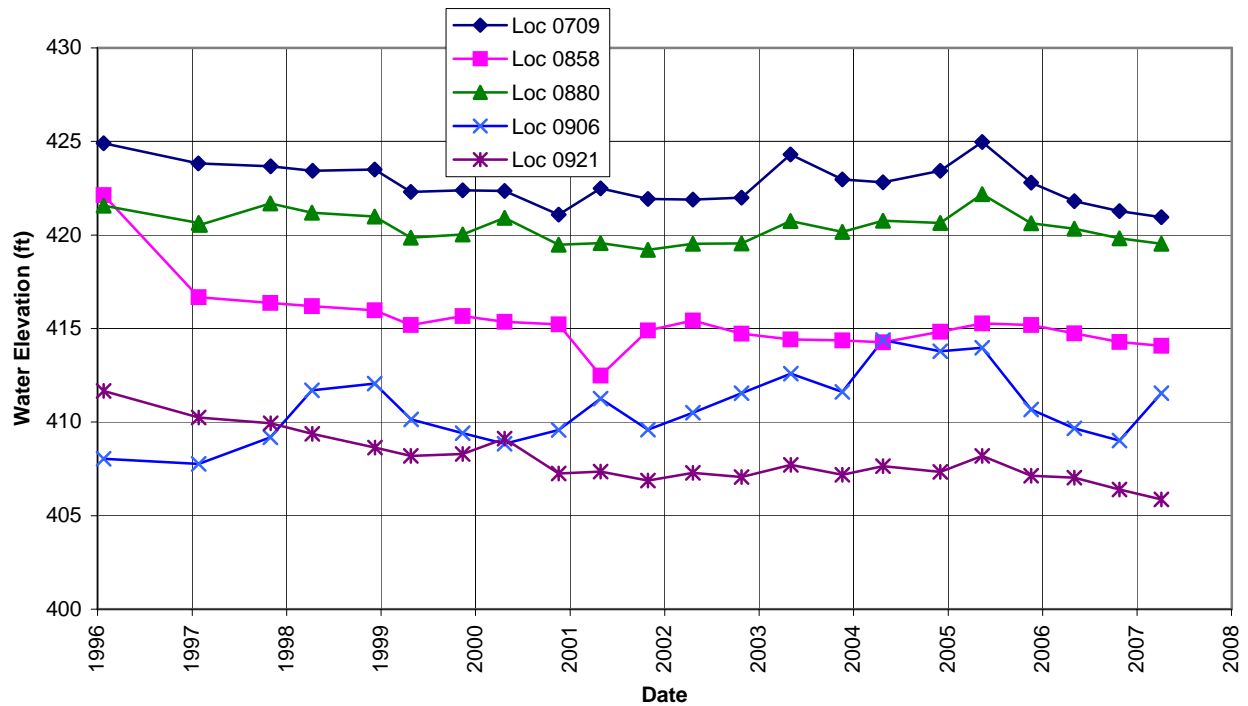
Figure 5-7. Water Level Measurements at Cell Performance Monitoring Locations at the Falls City, Texas, Disposal Site

Groundwater Level Monitoring Results—Groundwater levels in the disposal cell performance network wells initially declined by several feet for the first few years following construction with one exception; monitor well MW–0906 fluctuated up and down several feet before rising and exhibiting an historical upward trend (Figure 5–7). The remaining wells displayed some fluctuations following an initial decline, but historically display a slight downward trend. Monitor well MW–0906 is located directly down slope of the disposal cell, and the historical upward trend is likely the result of percolating water shed by and conveyed away from the disposal cell, with fluctuations reflecting variations in annual precipitation. Other contributors that may influence local groundwater levels include; (1) dissipation of the processing site-related groundwater mound beneath the disposal cell, and (2) dissipation of transient drainage from the disposal cell.

Two cell performance monitor wells, MW–0908 and MW–0916, are not shown on Figure 5–7. These wells, designated for groundwater level monitoring only, are completed in the unsaturated zone of the Conquista Sandstone and have been dry since 1996.

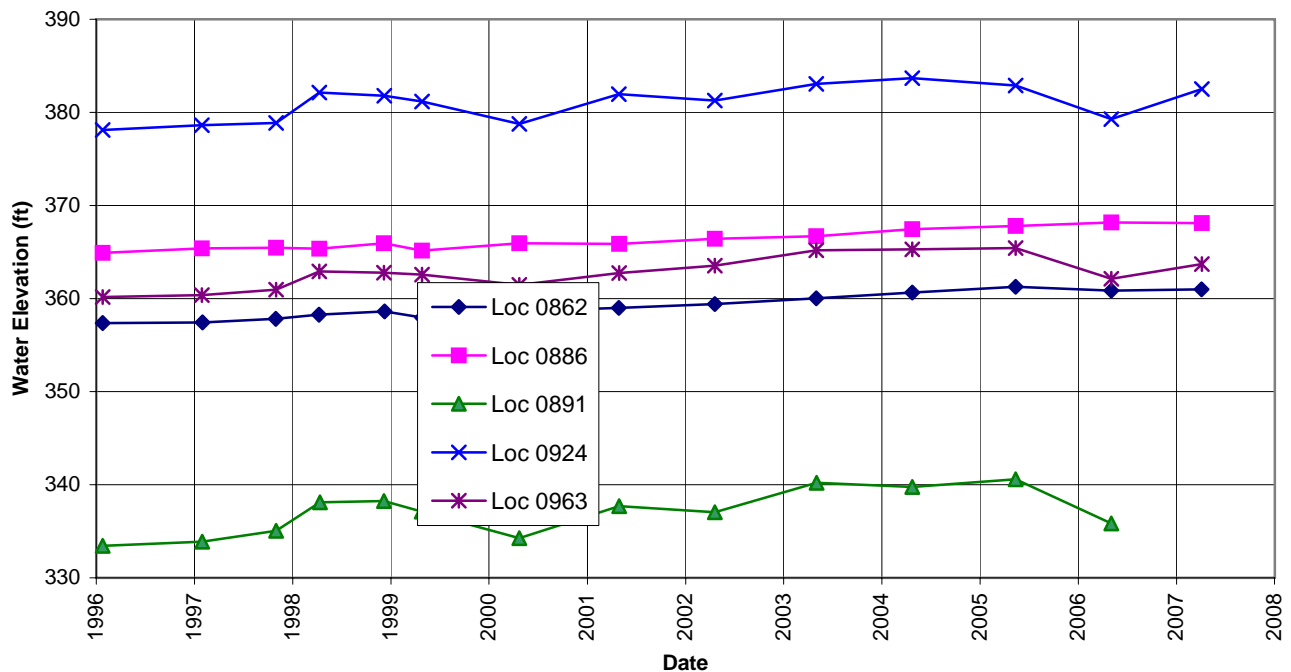
Figure 5-8. Water Level Measurements at Compliance Monitoring Locations at the Falls City, Texas, Disposal Site

In contrast, water levels in the groundwater compliance-monitoring network wells have all steadily increased several feet since monitoring began in 1996, indicating a regional effect (Figure 5–8). Water levels in 2005 and 2006, in all but one well (MW–0886), also show recent downward levels that likely represent drought conditions that occurred in 2005. In 2007 the water levels in four wells increased again, likely reflecting the wet spring of 2007.

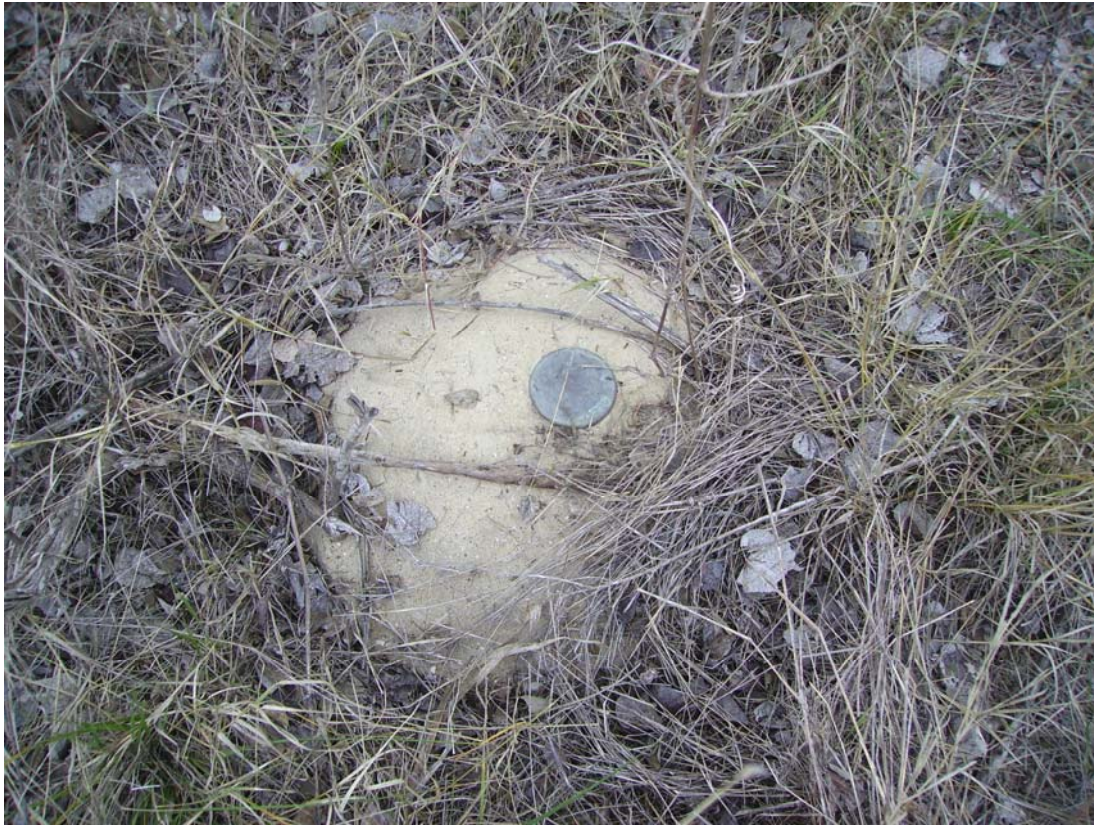
Three survey monuments and two boundary monuments situated at the corners of the site are undisturbed and in excellent condition. Vegetation was removed from around survey monument SM–2 (PL–1).

FCT 1/2007. PL-1. Vegetation cleared at survey monument SMK-2.

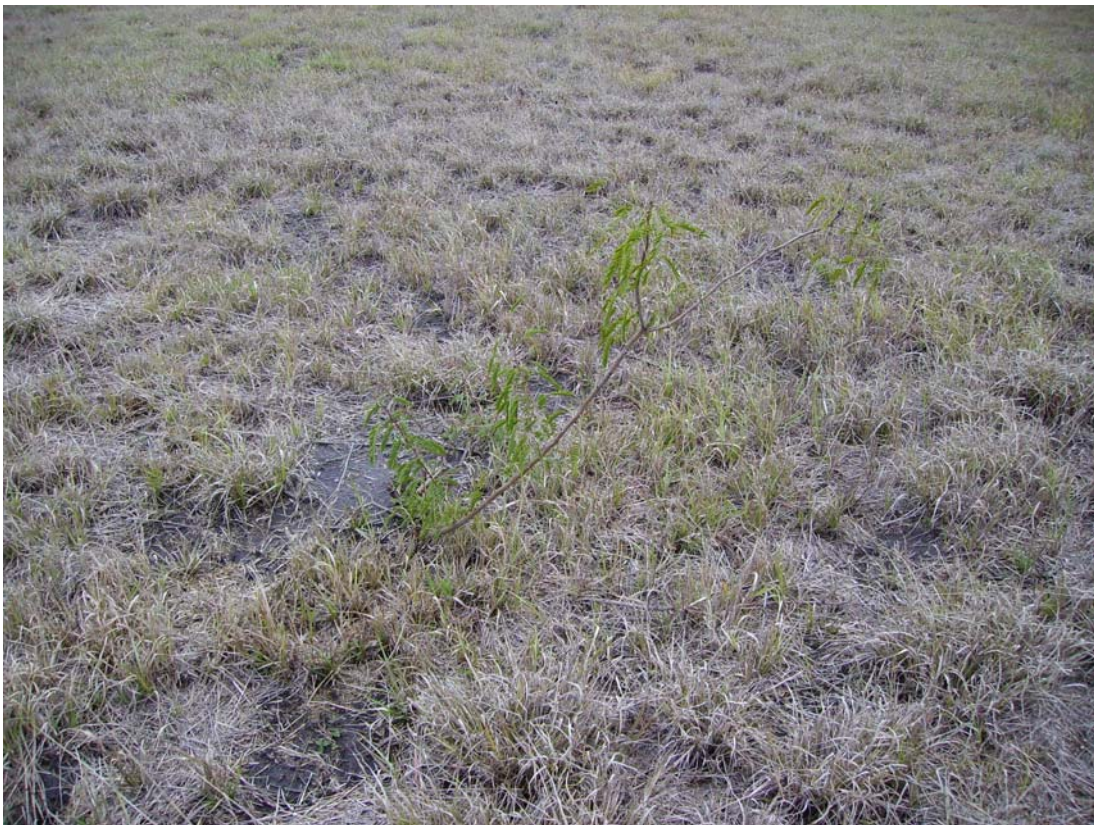
Top and Side Slopes of the Disposal Cell—The top of the disposal cell is covered with well-established grass and in good condition. Occasional mesquite seedlings, a deep-rooted tree, are scattered across the cell top (PL–2). A local rancher cuts hay each year from the disposal site, including the top of the cell (PL–3). The grass on the cell top had been cut short to control the risk of fire. Vegetation is dense and no sparse or barren areas were noted. There are no deep-rooted plants remaining on top of the disposal cell once the grass is cut.

FCT 1/2007. PL-2. Mesquite seeding on disposal cell top.

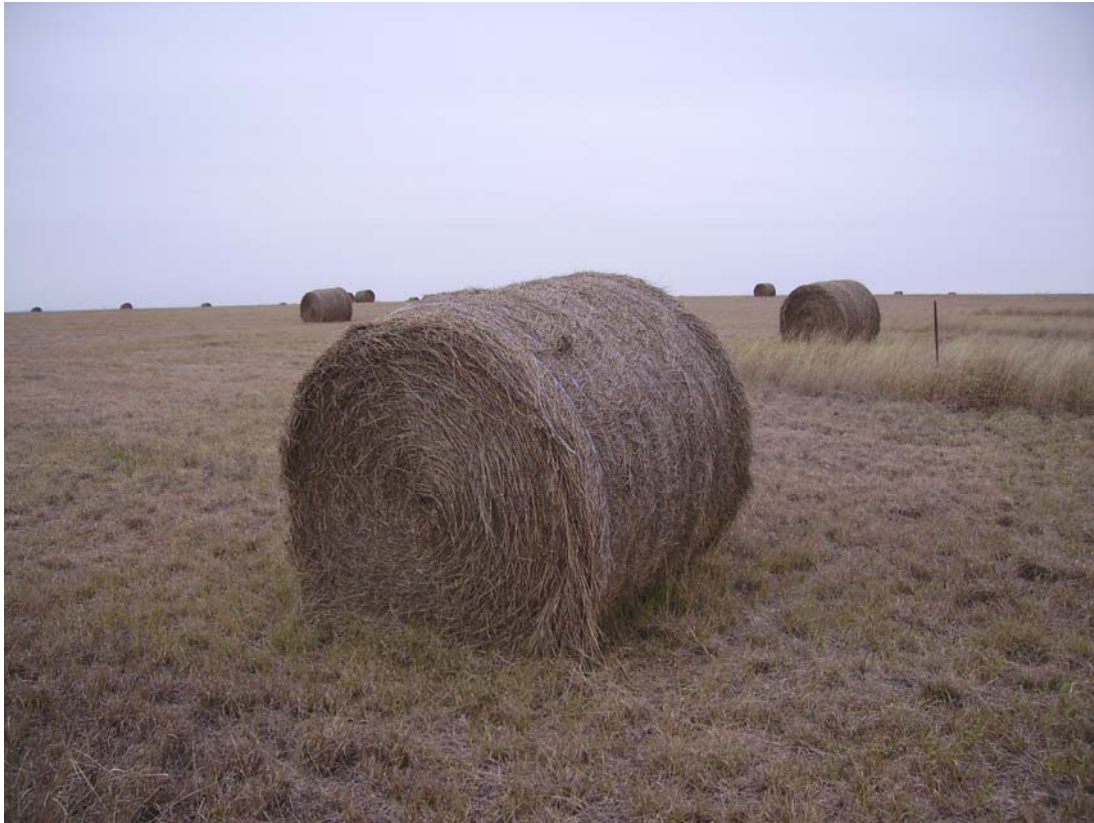
FCT 1/2007. PL-3. Hay bales harvested by subcontractor.

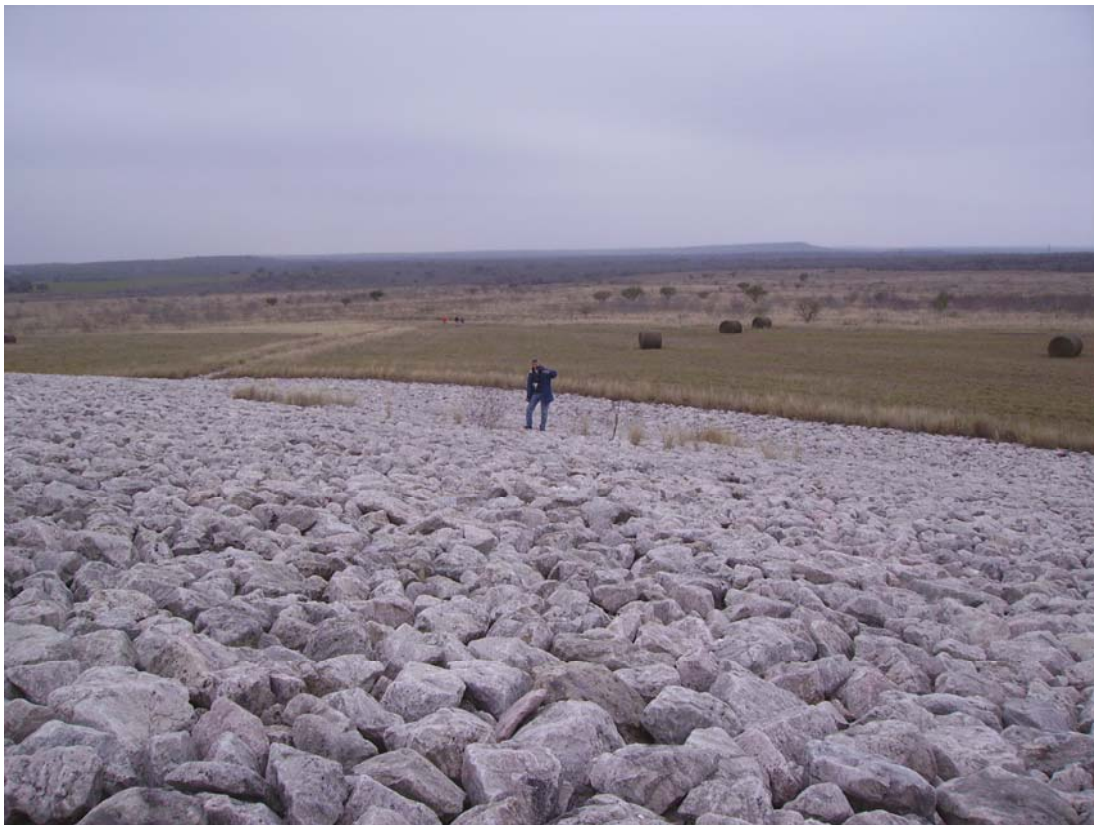
A slight slumping of riprap at the toe of the southwest corner of the side slope may be present (PL-4). Although this is likely an artifact of construction, particular attention will be paid to this area during future inspections to determine if any movement is occurring.

FCT 1/2007. PL-4. Southwest corner of the disposal cell side slope.

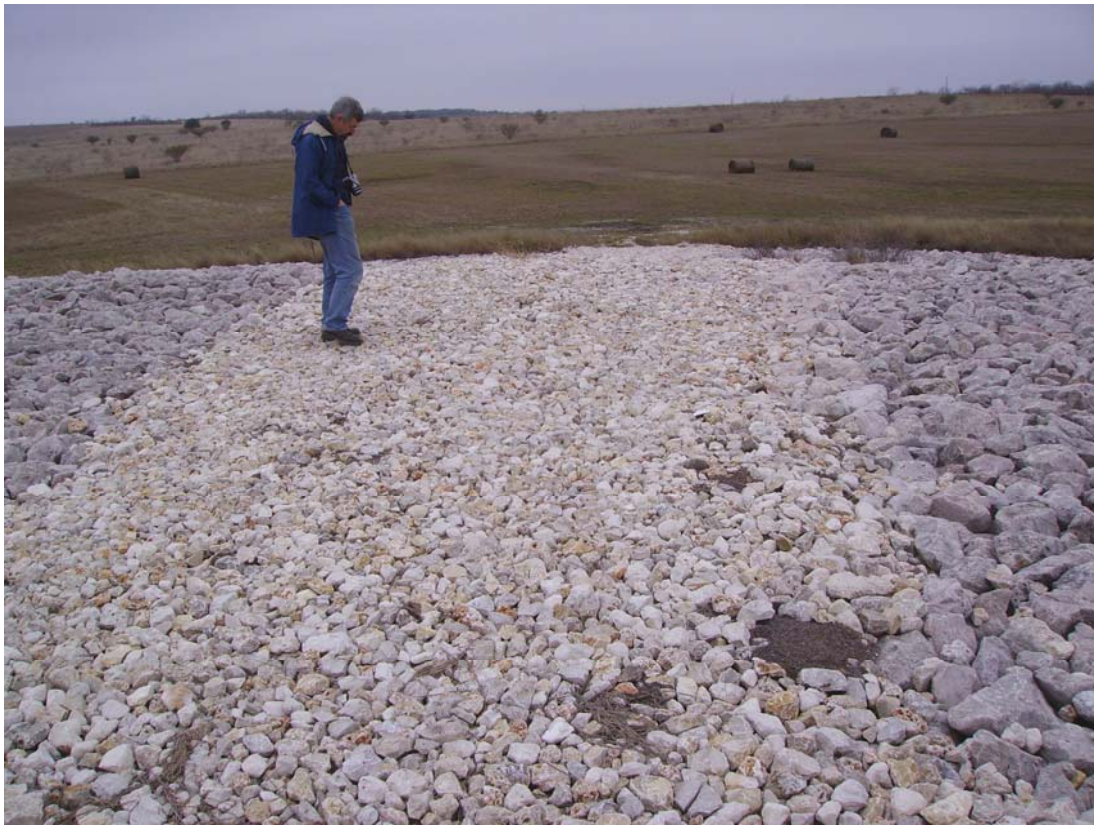
An access ramp was installed at the west corner of the side slope in 2006 to facilitate access by maintenance equipment to the top of the cell (PL-5). No changes in the access ramp or side slope were observed.

FCT 1/2007. PL-5. Access ramp at west corner of the disposal cell side slope.

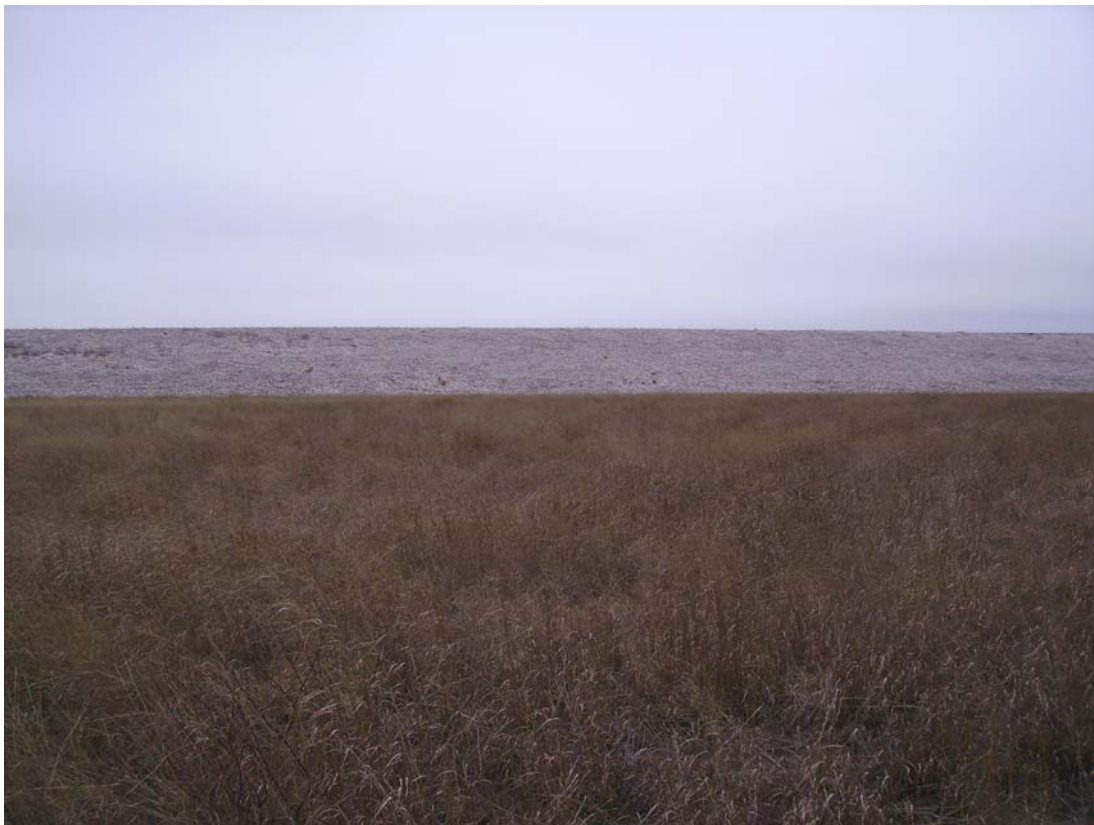
Small, scattered deep-rooted trees and bushes remain in the riprap on the side slopes of the disposal cell and distribution appears similar to last year. Much of the vegetation seen on the side slopes was either dead or dormant grass. Deep-rooted vegetation is of particular concern because it can penetrate the radon barrier. As in previous inspections, a reference photograph was taken (near perimeter sign P11) of vegetation growth occurring on the southeast side slope (PL-6).

FCT 1/2007. PL-6. Reference photo of side slope vegetation from perimeter sign P11.

5B Control of undesirable vegetation on the side slopes will be ongoing, including cutting the deep-rooted species and applying a systemic herbicide to the stumps.
